MISSION AMRIT SAROVAR

JAL DHAROHAR SANRAKSHAN INTERNSHIP

Water Body Name: **SEMBIRANKULAM**

DETAILED PROGRESS REPORT

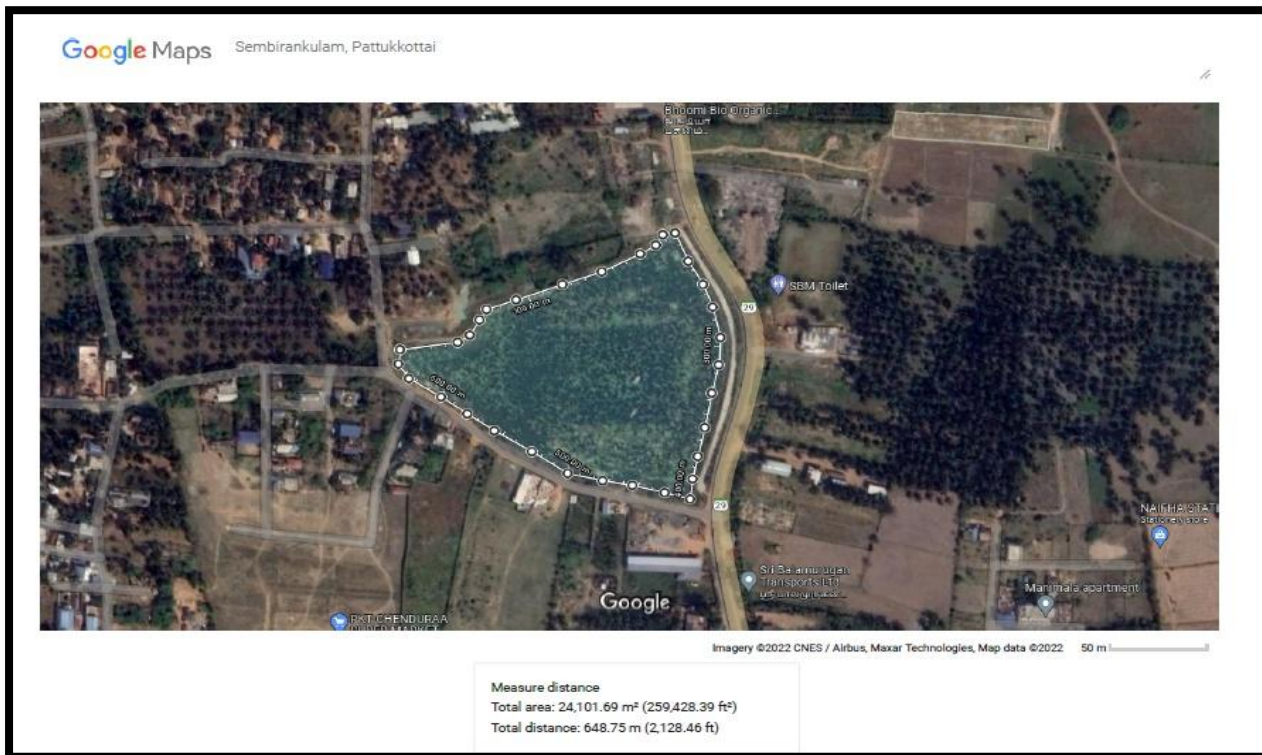
SPATIAL TEMPORAL ANALYSIS

- ✓ **Spatial temporal analysis was done, to analyze the land-use changes and their impact on the water body and surrounding area.**
- ✓ **Analysis was carried out from the primary and secondary data collected from the Municipal office and Google earth.**
- ✓ **QGIS software is used for performing the spatial temporal analysis. QGIS is used for relating, integrating, and analyzing information of the water body.**
- ✓ **We also observed that, there is a gradual decrease in the boundary of the water body.**
- ✓ **With the help of the spatial temporal analysis we can examine the behavior of the water body.**
- ✓ **Comparison of the calculated area of the water body with the map values and reasons for decrease in area of the water body were identified.**
- ✓ **Student interns actively participated in group discussion regarding the spatial temporal analysis.**

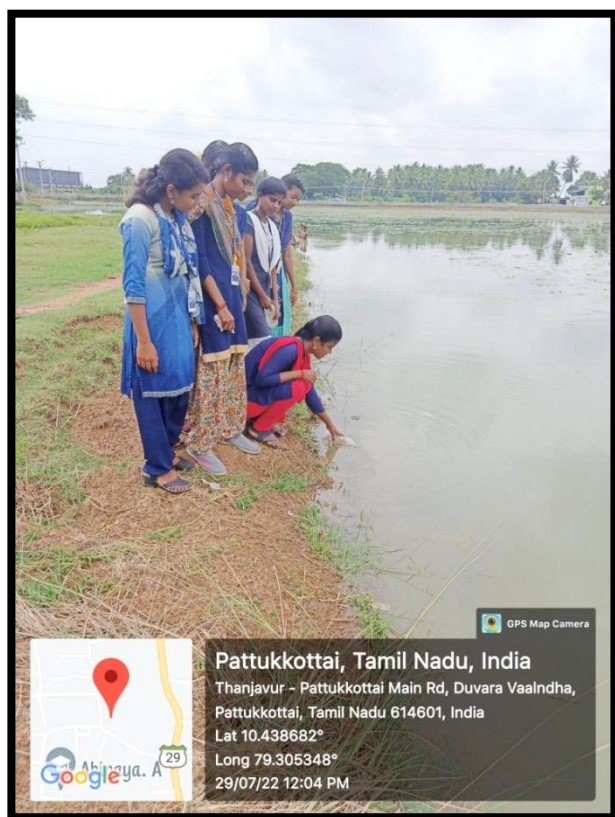
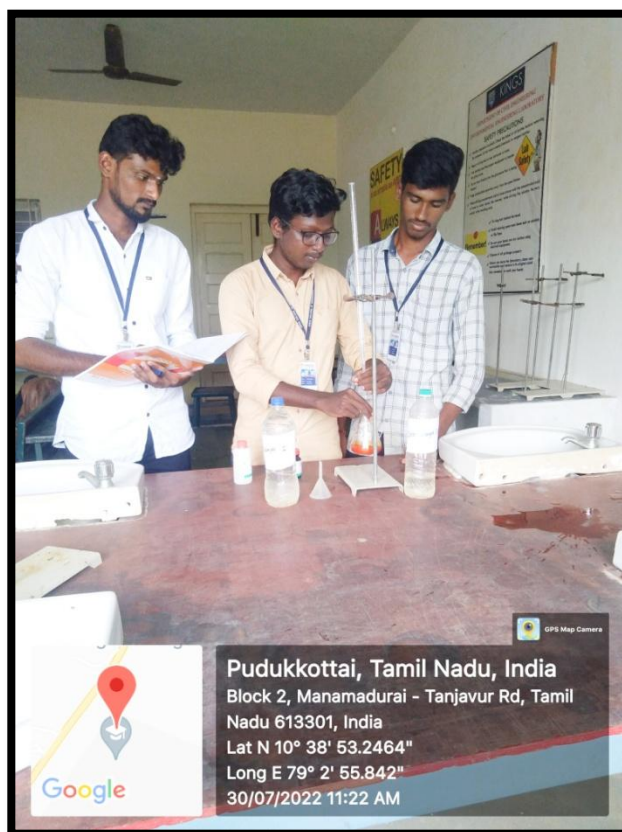
WATER SAMPLING & TESTING

- ✓ **Water samples were collected. Since the depth was more, samples were collected from the boundary areas only, for safety purposes.**
- ✓ **Collected water samples were tested in our laboratory. Various water quality parameters like pH, BOD, COD, Turbidity and Alkalinity were analyzed.**

S.NO	TEST CONDUCTED	RESULT	REMARKS
1	pH	8.5	Water is alkaline in Nature.
2	BOD	250 ppm	High BOD value, because of solid waste disposal into the water body.
3	COD	350 mg/l	High COD value, due to the presence of oxidizable organic matter in the water body.
4	Turbidity	9.5 NTU	It indicates the water quality as BAD.
5	Alkalinity	135 mg/l	Presence of sewage in the water body makes the water more alkaline.

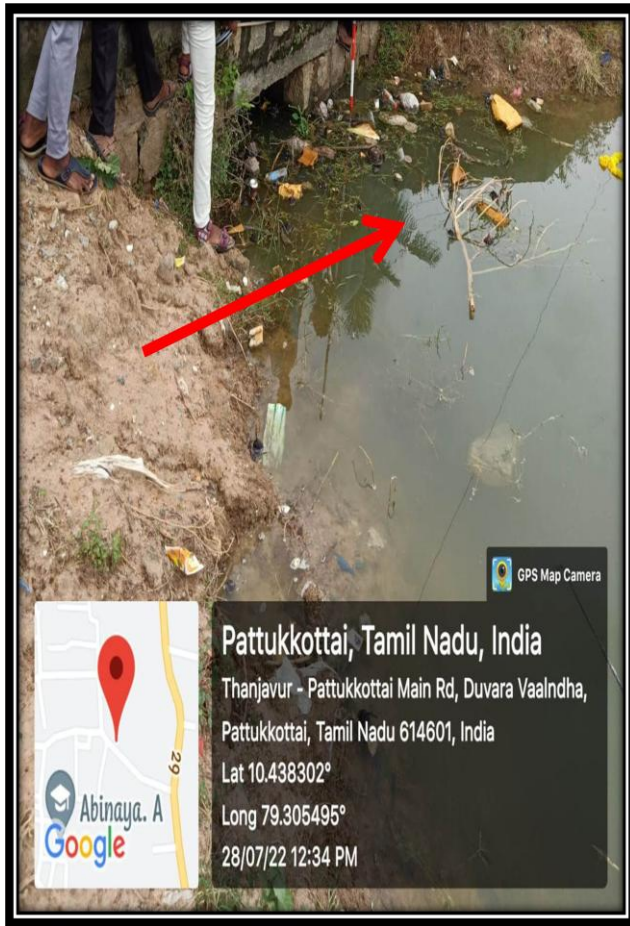
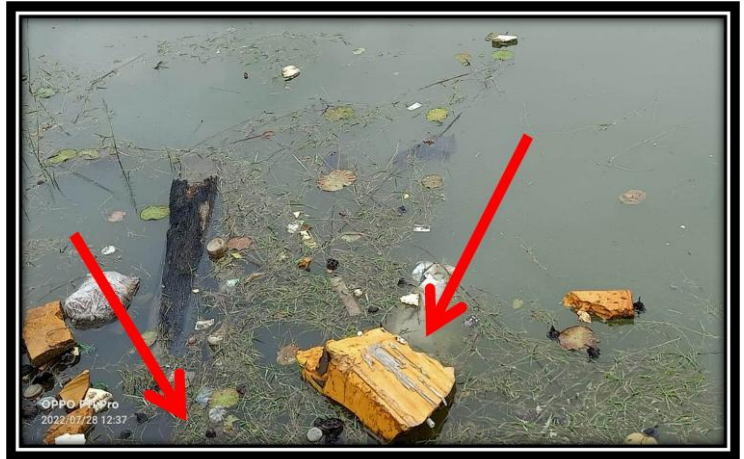
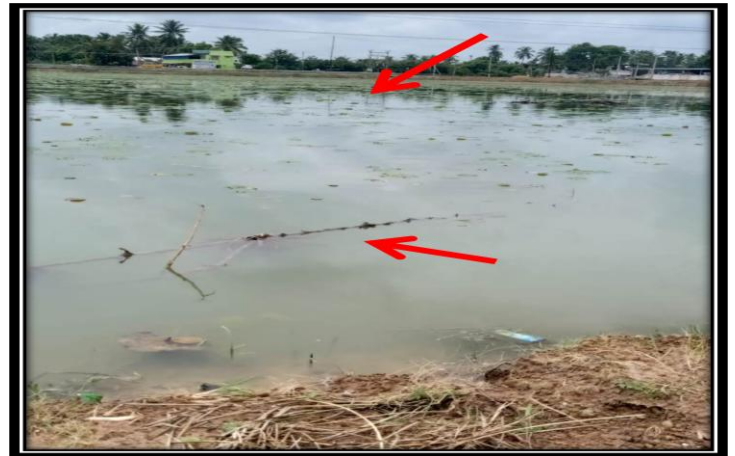
HEALTH OF THE WATERBODY

- ✓ The water body is not clean. It has lot of garbage, plastic wastes and algae spread over it and is not good for drinking.
- ✓ Presence of solid wastes and organic matters in the water body has increased the BOD, COD level.
- ✓ Alkalinity level also seems to be high due to sewage mixing in the water body.
- ✓ Another water quality parameter tested was Turbidity and found to be 9.5 NTU. It indicates the water quality as BAD.
- ✓ From the results of the water sample testing, it may be concluded that, the water from Sembirankulam is not good for drinking. The water body may be utilized for irrigation but proper measures are to be taken for clearing the garbage, plastic wastes and algae spread over the water body.

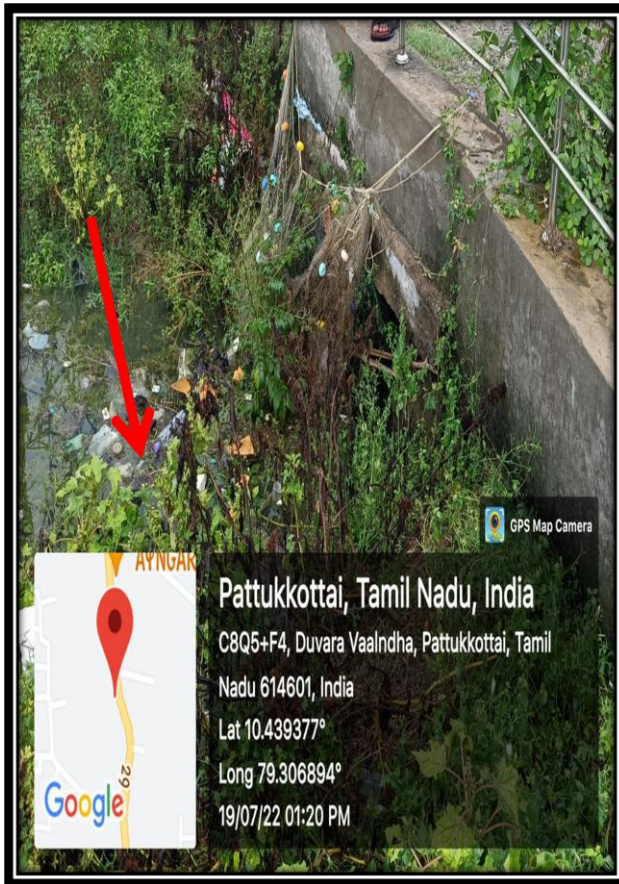
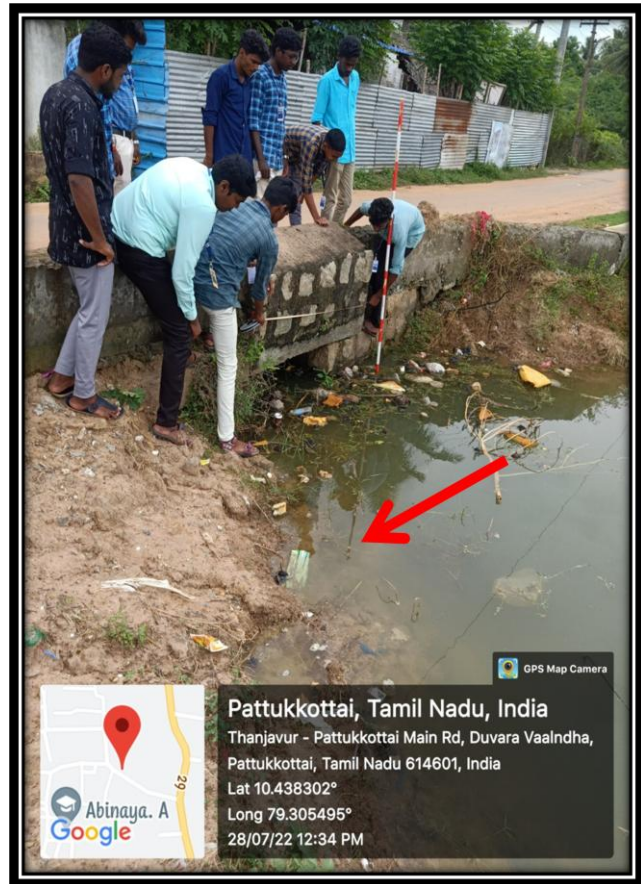
STATUS OF CHANNEL INFLOW

- ✓ The inlet of the water body was analyzed by our interns.
- ✓ The water body has 2 inlets and both the inlets are surrounded by garbage and plastic wastes.
- ✓ The inlet should have a proper screening to avoid entry of solid particles into the water body.
- ✓ Also because of the garbage, organic wastes & plastic wastes the water quality parameter has also drastically changed.
- ✓ Out of the 2 inlets, screening was available in 1 inlet. But it is damaged and hence garbage, organic wastes & plastic wastes enters the water body.
- ✓ In addition during rainy days water flow might get reduced, due to the presence of garbage, organic wastes & plastic wastes at the inlet, that affecting the level of the water body.

- ✓ **Screening should be done at the water body inlet to avoid entry of garbage, organic wastes & plastic wastes into the water body.**
- ✓ **Pathway is provided at one side of the water body. It should be extended on all sides.**

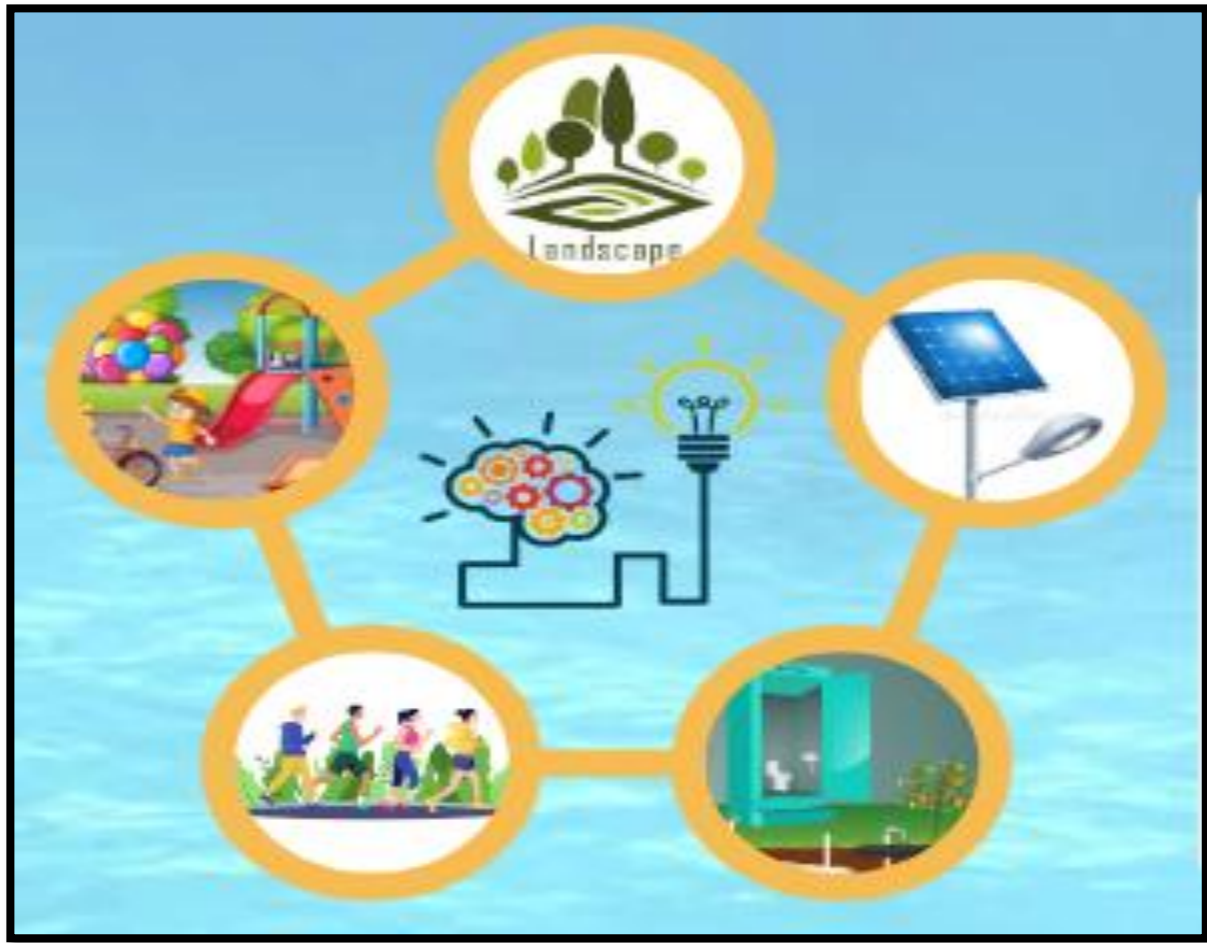
SCOPE FOR REJUVENATION

SEMBIRANKULAM water body can be rejuvenated as a vibrant public place by providing:

- ✓ **Landscape near the water body.** It gives good ambience to the water body thereby attracting the people to visit the place.
- ✓ **Play area for children.** It attracts the kids.
- ✓ **Path-way for walking and exercise.** Youngsters and enthusiastic people will utilize the place for physical training.
- ✓ **Lightings using solar panels.** It gives eco-friendly provision for electricity and safety during night time.
- ✓ **Bio-toilets for public use.** It will keep the place tidy and also acts as a provision for nature calls.

- ✓ **Washing & bathing should be prohibited at the water body and water should be used only for fishing & irrigation.**
- ✓ **Landscaping, kids play area, pathway for walking & exercise, solar lightings, bio-toilets can be provided at the water body for vibrant public use.**

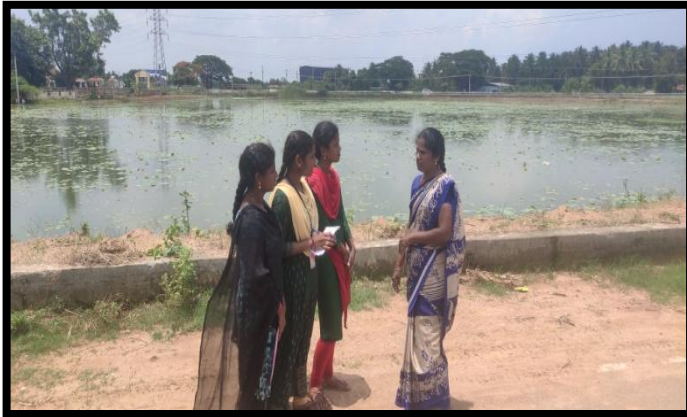
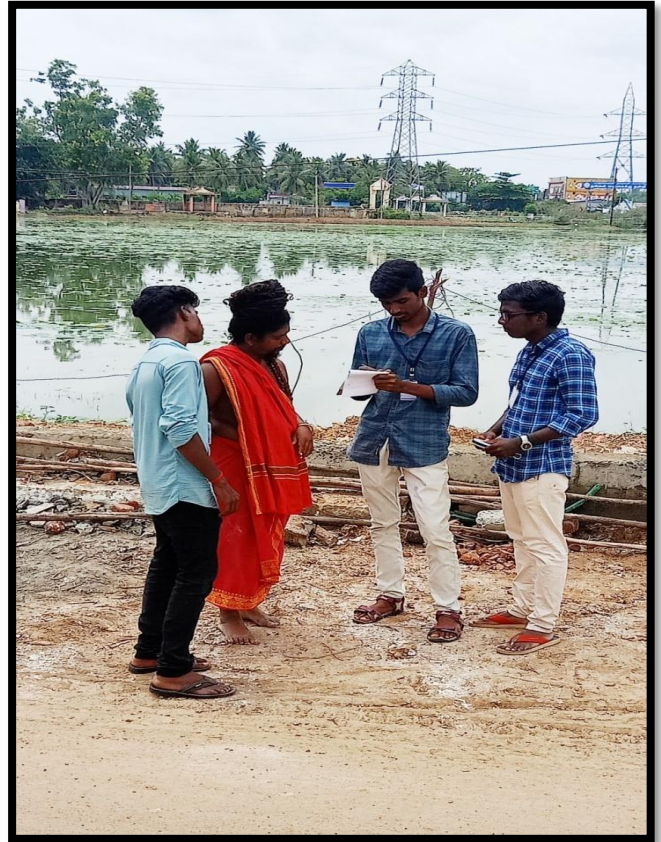
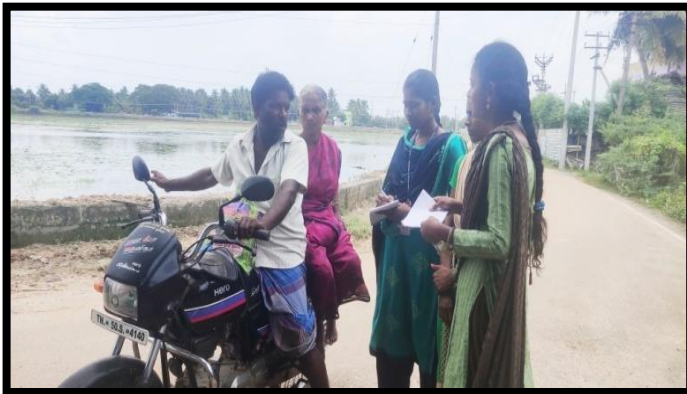
OTHER HIGHLIGHTS OF THE WATER BODY

Our interns conducted a survey among the local people and gathered information about the water body.

- ✓ **The water body is mainly used for fishing and irrigation purposes.**
- ✓ **The boundary of the water body has been drastically reduced.**
- ✓ **The quality of the water body has been dropped because of improper maintenance.**
- ✓ **Proper awareness should be created among the people to avoid littering.**

- ✓ **Local people use the water body for washing and bathing, which should be prohibited. Since it will affect the aquatic life of the water body.**
- ✓ **Since the water body is located in a rural area, some people are using it as a toiletry place. It should be strictly prevented.**
- ✓ **Local people should avoid littering near/into the water body.**

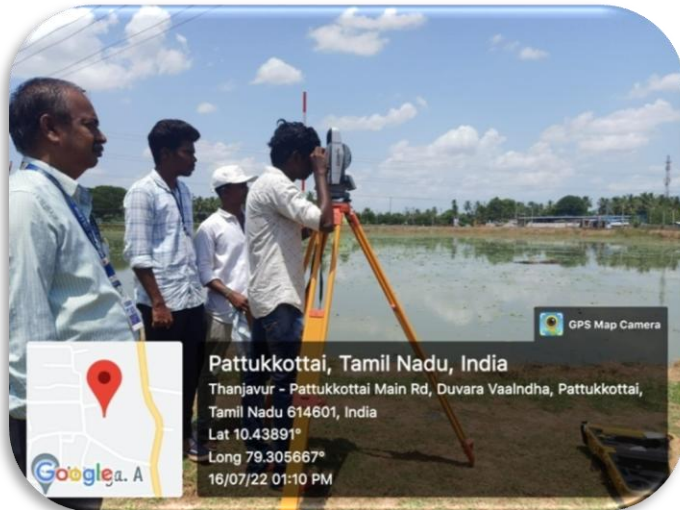
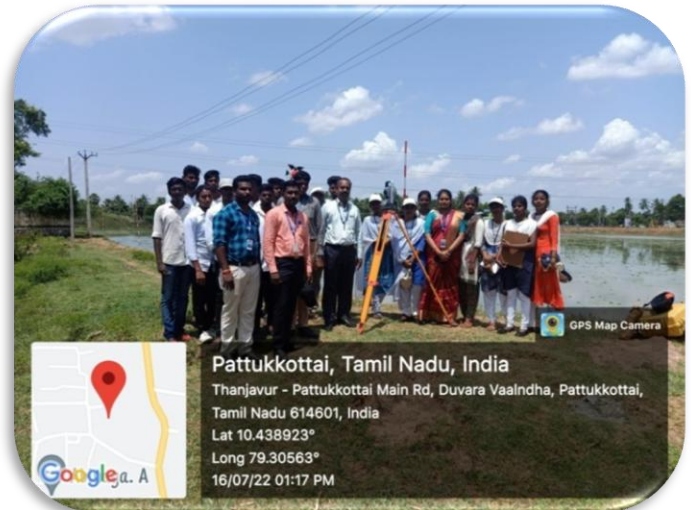
Surveying at SEMBIRANKULAM water body using Total station

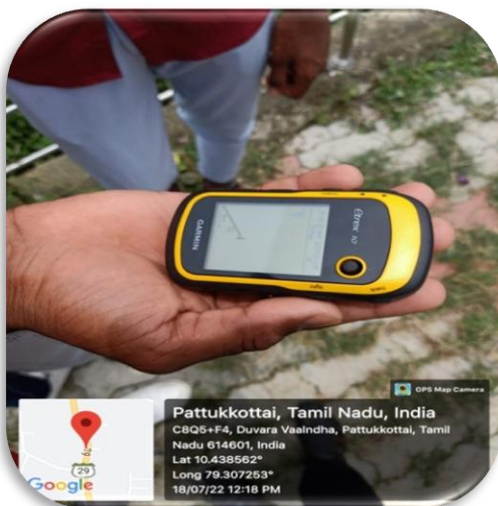
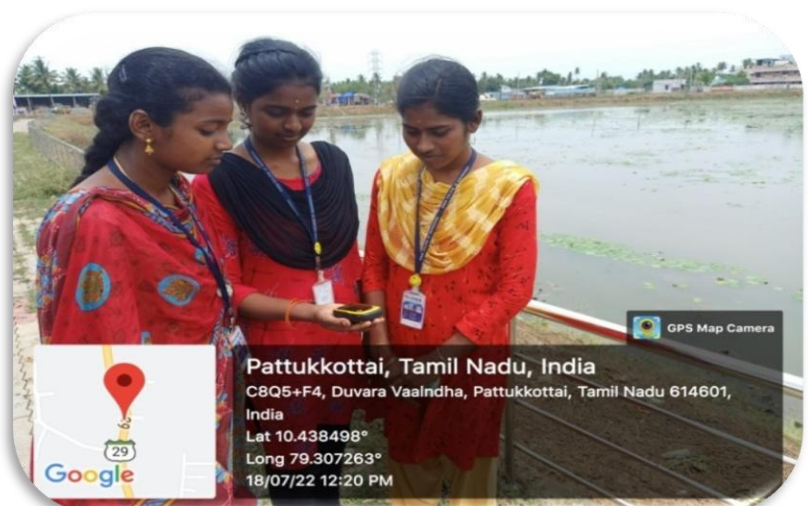
Surveying at SEMBIRANKULAM water body using GPS

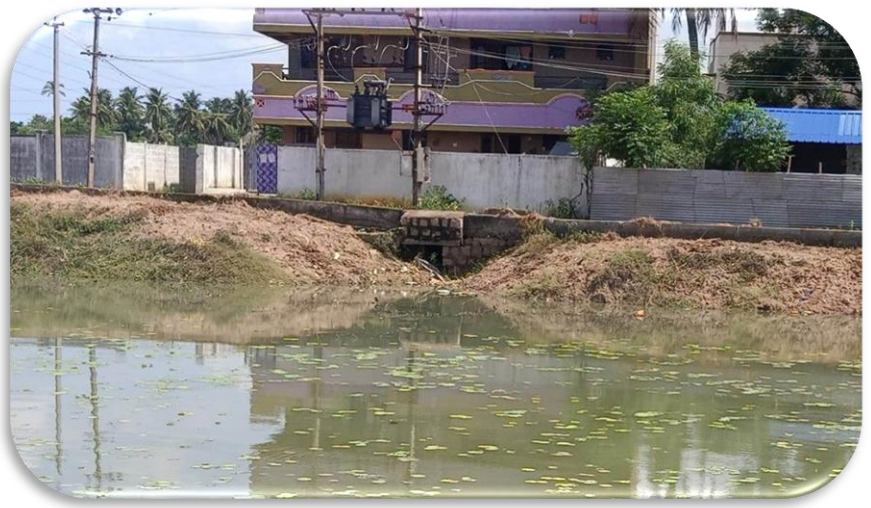
Inlet at the water body, Sembirankulam

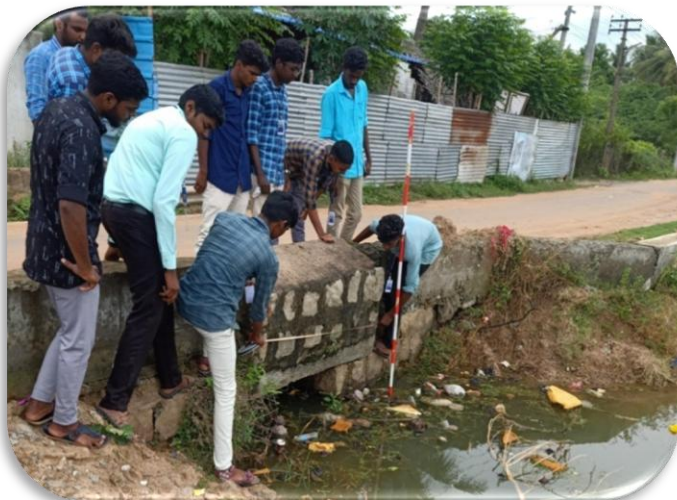
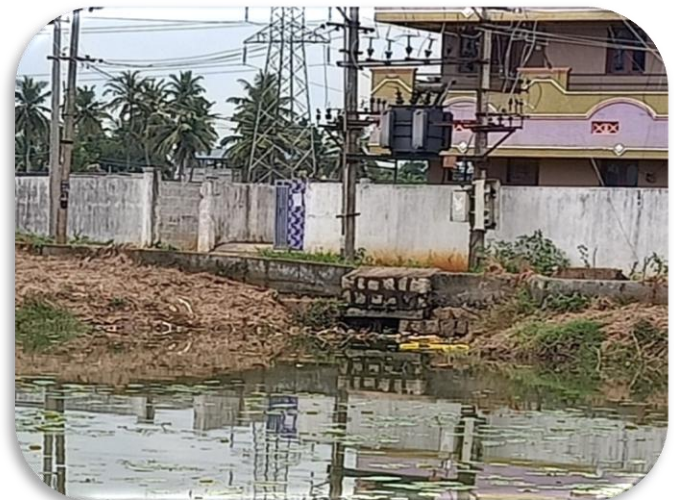
Inspection of the water body inlet

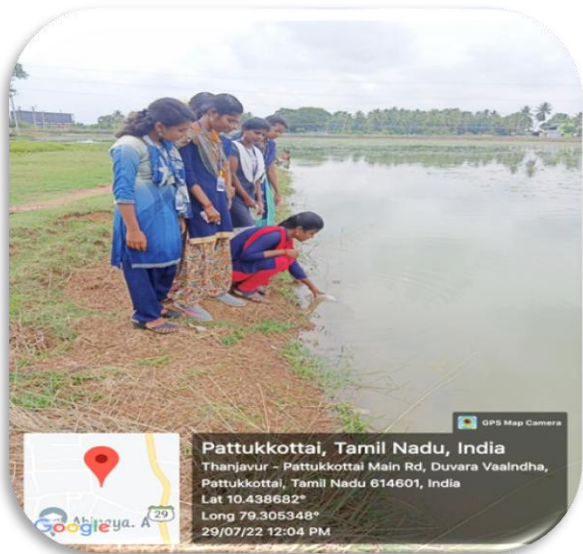
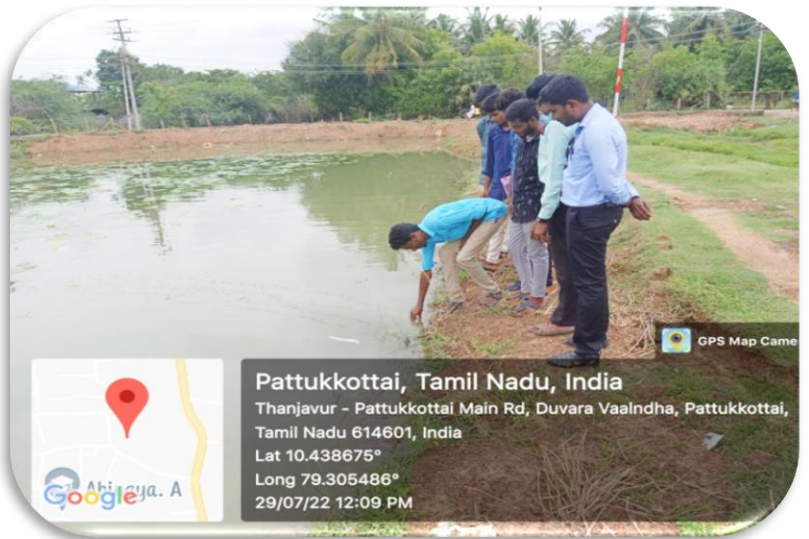
Collection of water samples at the waterbody, Sembirankulam

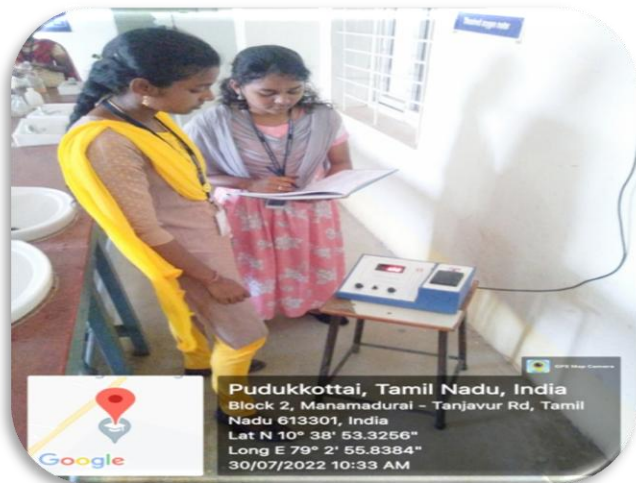
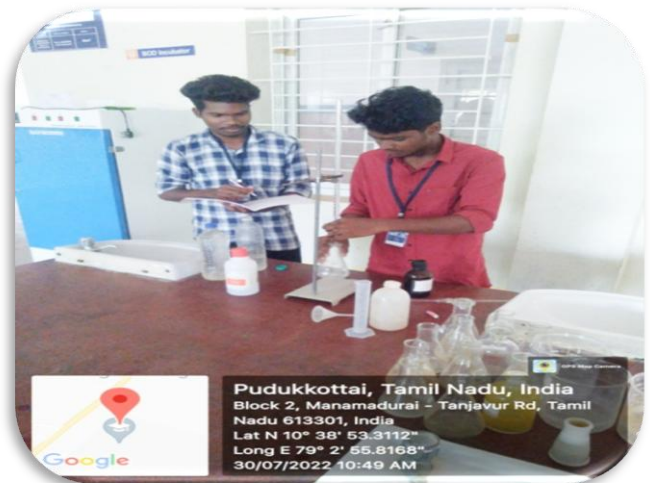
Water sample testing at lab
